**Flood Control Project Maintenance
Levee Inspections**

Maintenance Issue Types Only, Levee Inspection Report By Mile - Spring 2017

Reclamation District No. 0524 Middle Roberts Island

Waterway	Bank	Unit Miles	Inspection Start/End	Inspector
Unit No. 01 San Joaquin River	Left	6.20	04/04/2017 04/05/2017	Richard Willoughby

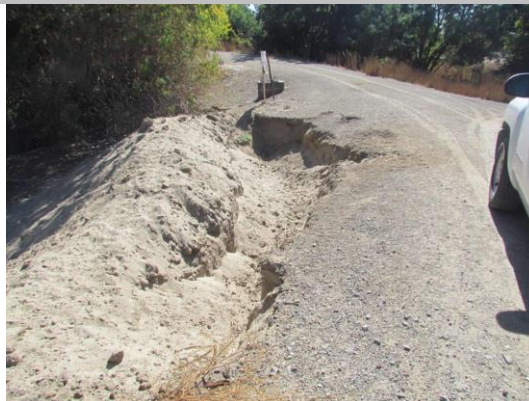
Photo 3 of 3 : SP_2017_RD0524_107_218_20170316_00257.jpg

LM Start	2.57	Rating **	U	Issue No.	218 (cont)	
LM End	2.57	Issue Type +	Ma	Location *	WS	
Category	Earthen Levee			GPS Latitude/Longitude		
				Start		End
Item	Erosion / Bank Caving			37.917492 °		37.917492 °
				-121.322795 °		-121.322795 °
DWR ID	DWR_RD0524_01_f_2016_218					
Comment Code						
E2 : Schedule repair of erosion site prior to the next inspection.						
Inspector Comment						
Large trench on waterward shoulder and slope. Trench is 45 x 15 x 5.

Looking south at trench on waterward shoulder.

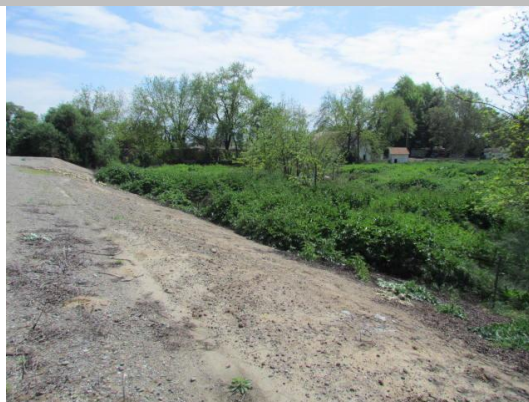
Photo 1 of 1 : SP_2017_RD0524_107_9_20170316_00016.jpg

LM Start	2.59	Rating **	U	Issue No.	9
LM End	2.63	Issue Type +	Ma	Location *	LS
Category	Earthen Levee			GPS Latitude/Longitude	
				Start	End
Item	Vegetation			37.917228 °	37.916858 °
				-121.322730 °	-121.322168 °
DWR ID	DWR_RD0524_01_s_2012_9				
Comment Code					
V2 : Remove the wild growth other than native grasses from the levee slopes.					
Inspector Comment

Looking southwest at dense veg at landward toe.

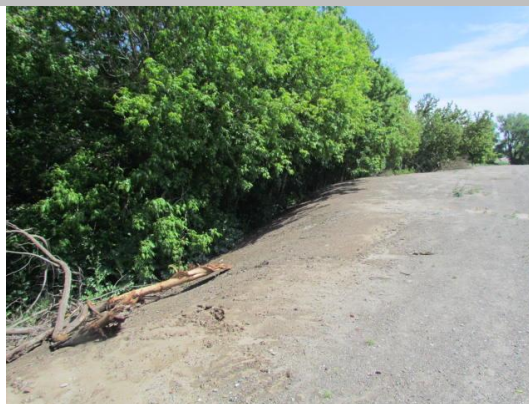
Photo 1 of 1 : SP_2017_RD0524_107_185_20170316_00220.jpg

LM Start	2.60	Rating **	U	Issue No.	185
LM End	2.64	Issue Type +	Ma	Location *	WS
Category	Earthen Levee			GPS Latitude/Longitude	
				Start	End
Item	Trim / Thin Trees			37.917152 °	37.916807 °
				-121.322582 °	-121.322069 °
DWR ID	DWR_RD0524_01_s_2014_185				
Comment Code					
T2 : Thin trees to allow visibility of the ground and room to flood fight.					
Inspector Comment

Looking northwest at untrimmed trees on landward slope and toe.

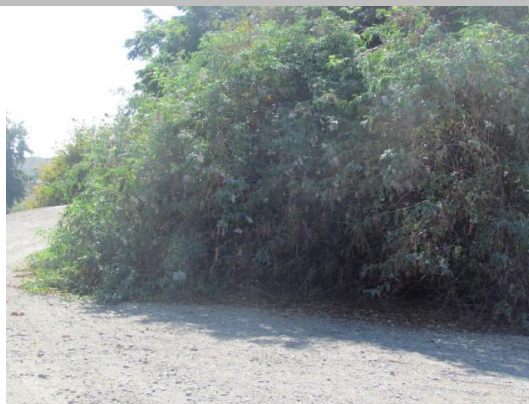
Photo 1 of 1 : SP_2017_RD0524_107_43_20170316_00080.jpg

LM Start	2.64	Rating **	U	Issue No.	43
LM End	2.64	Issue Type +	Ma	Location *	LS
Category	Earthen Levee			GPS Latitude/Longitude	
				Start	End
Item	Vegetation			37.916780 °	37.916780 °
				-121.322095 °	-121.322095 °
DWR ID	DWR_RD0524_01_s_2012_43				
Comment Code					
V4 : Elderberries are blocking visibility and flood fight capability.					
Inspector Comment					
Dense elderberry on landward shoulder, slope, and toe.

Looking southeast at dense veg on landward slope and toe fall 2015.

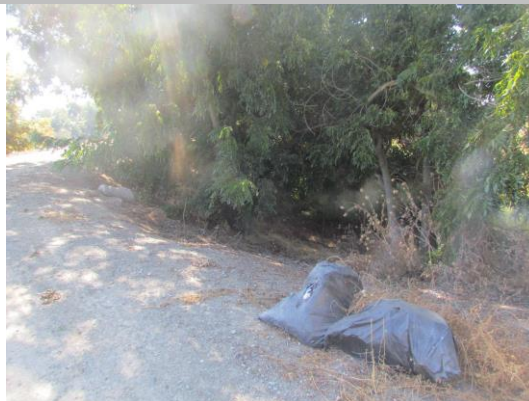
Photo 1 of 1 : SP_2017_RD0524_107_918_20170316_00277.jpg

LM Start	2.65	Rating **	U	Issue No.	918
LM End	2.66	Issue Type +	Ma	Location *	LS
Category	Earthen Levee			GPS Latitude/Longitude	
				Start	End
Item	Trim / Thin Trees			37.916718 °	37.916502 °
				-121.322020 °	-121.321980 °
DWR ID	DWR_RD0524_01_s_2012_918				
Comment Code					
T1 : Trim trees to at least five feet above ground level.					
Inspector Comment					
Untrimmed trees on landward slope and toe.

Looking south at untrimmed trees on landward slope.

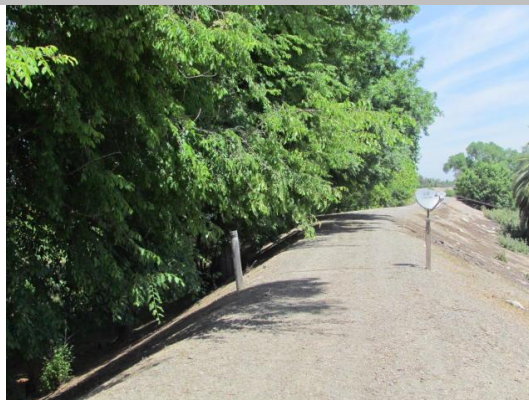
Photo 1 of 1 : SP_2017_RD0524_107_44_20170316_00081.jpg

LM Start	2.67	Rating **	M	Issue No.	44
LM End	2.77	Issue Type +	Ma	Location *	LS
Category	Earthen Levee			GPS Latitude/Longitude	
				Start	End
Item	Trim / Thin Trees			37.916418 °	37.915142 °
				-121.321963 °	-121.323018 °
DWR ID	DWR_RD0524_01_s_2012_44				
Comment Code					
T4 : Trim trees over roadway to at least 12 feet above ground level.					
Inspector Comment					
Trim over hanging trees at least 12 feet above ground level.

Looking north at dense trees overhanging levee crown.

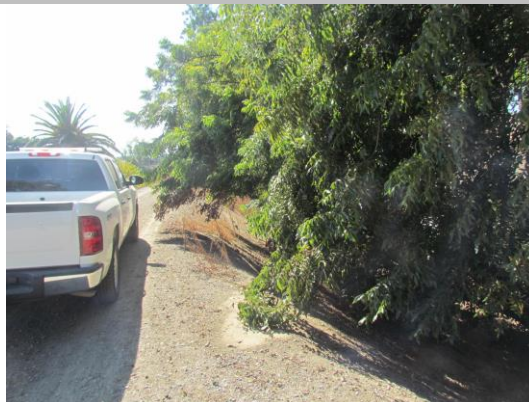
Photo 1 of 1 : SP_2017_RD0524_107_264_20170316_00266.jpg

LM Start	2.70	Rating **	U	Issue No.	264
LM End	2.74	Issue Type +	Ma	Location *	LS
Category	Earthen Levee			GPS Latitude/Longitude	
				Start	End
Item	Trim / Thin Trees			37.915968 °	37.915557 °
				-121.322275 °	-121.322607 °
DWR ID	DWR_RD0524_01_s_2012_264				
Comment Code					
T2 : Thin trees to allow visibility of the ground and room to flood fight.					
Inspector Comment					
Untrimmed trees along landward slope and toe.

Looking south at untrimmed trees on landward slope.

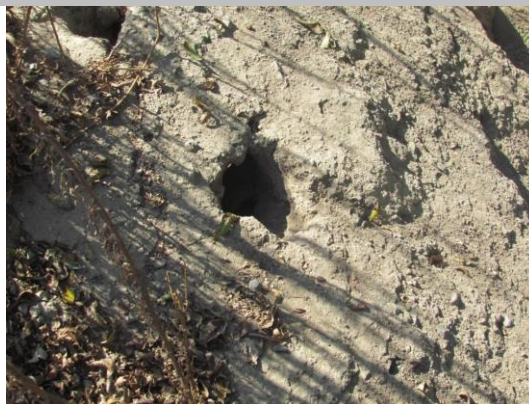
Photo 1 of 2 : SP_2017_RD0524_107_219_20170316_00258.jpg

LM Start	2.77	Rating **	U	Issue No.	219
LM End	2.80	Issue Type +	Ma	Location *	LS
Category	Earthen Levee			GPS Latitude/Longitude	
				Start	End
Item	Animal Control			37.915195 °	37.915052 °
				-121.322930 °	-121.323430 °
DWR ID	DWR_RD0524_01_f_2016_219				
Comment Code					
A1 : Exterminate rodents and backfill and compact or grout burrows.					
Inspector Comment					
Several large rodent holes on landward slope.

Looking at typical rodent hole on waterward slope.

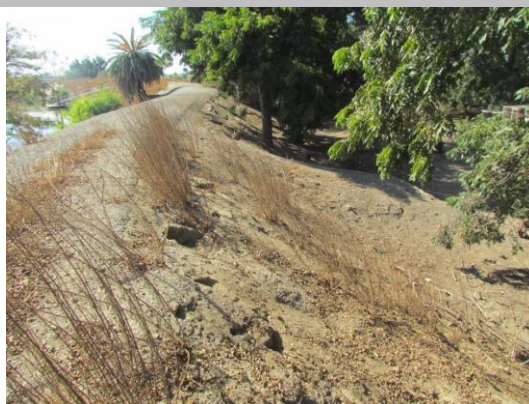
Photo 2 of 2 : SP_2017_RD0524_107_219_20170316_00259.jpg

Looking south at several rodent holes on landward slope.

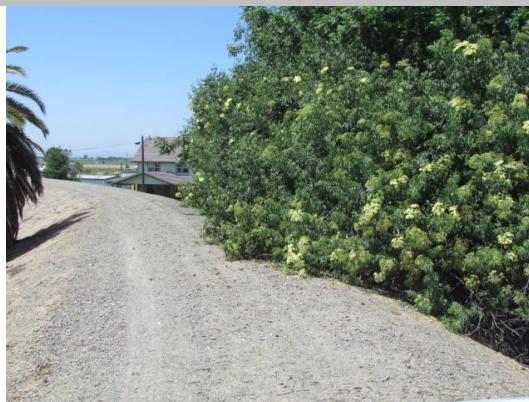
Photo 1 of 2 : SP_2017_RD0524_107_48_20170316_00091.jpg

LM Start	2.80	Rating **	U	Issue No.	48
LM End	2.80	Issue Type +	Ma	Location *	LS
Category	Earthen Levee			GPS Latitude/Longitude	
				Start	End
Item	Vegetation			37.915022 °	37.915022 °
				-121.323443 °	-121.323443 °
DWR ID	DWR_RD0524_01_s_2012_48				
Comment Code					
V4 : Elderberries are blocking visibility and flood fight capability.					
Inspector Comment

Looking south at dense elderberry on landside slope.(Spring 2012)

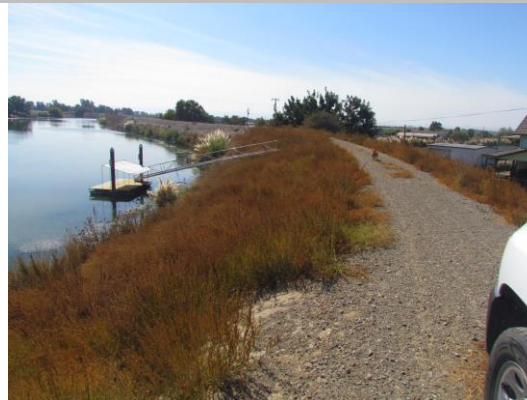
Photo 1 of 1 : SP_2017_RD0524_107_220_20170316_00260.jpg

LM Start	2.82	Rating **	A/W	Issue No.	220
LM End	2.87	Issue Type +	Ma	Location *	WS
Category	Earthen Levee			GPS Latitude/Longitude	
				Start	End
Item	Vegetation			37.914893 °	37.914258 °
				-121.323770 °	-121.324328 °
DWR ID	DWR_RD0524_01_f_2016_220				
Comment Code					
V1 : Control annual grass and weeds on the levee slopes and easements.					
Inspector Comment					
Dense vegetation on waterward slope.

Looking at dense veg on waterward slope.

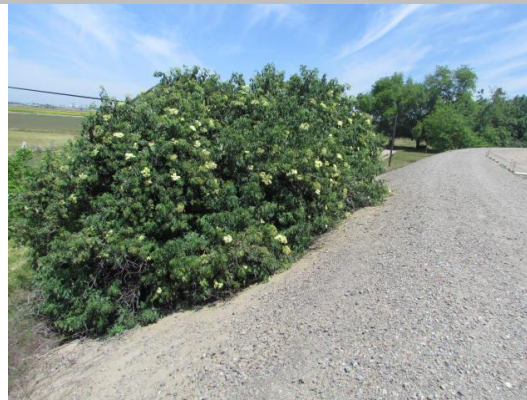
Photo 1 of 1 : SP_2017_RD0524_107_49_20170316_00093.jpg

LM Start	2.86	Rating **	U	Issue No.	49
LM End	2.86	Issue Type +	Ma	Location *	LS
Category	Earthen Levee			GPS Latitude/Longitude	
				Start	End
Item	Vegetation			37.914427 °	37.914427 °
				-121.324198 °	-121.324198 °
DWR ID	DWR_RD0524_01_s_2012_49				
Comment Code					
V4 : Elderberries are blocking visibility and flood fight capability.					
Inspector Comment

Looking northwest at elderberry on landside slope.

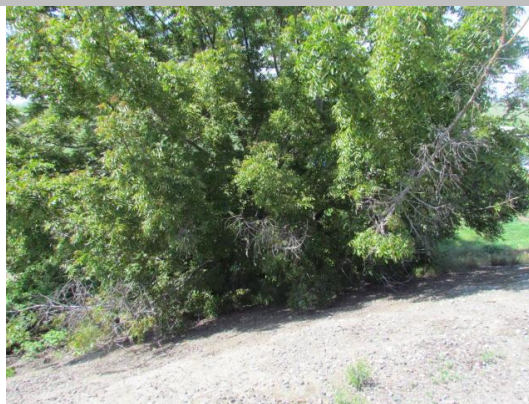
Photo 1 of 1 : SP_2017_RD0524_107_209_20170316_00242.jpg

LM Start	2.87	Rating **	U	Issue No.	209
LM End	2.87	Issue Type +	Ma	Location *	LS
Category	Earthen Levee			GPS Latitude/Longitude	
				Start	End
Item	Trim / Thin Trees			37.914257 °	37.914257 °
				-121.324317 °	-121.324317 °
DWR ID	DWR_RD0524_01_s_2016_209				
Comment Code					
T1 : Trim trees to at least five feet above ground level.					
Inspector Comment					
Untrimmed walnut tree on landward slope and toe.

Looking northwest at untrimmed tree at landward toe.

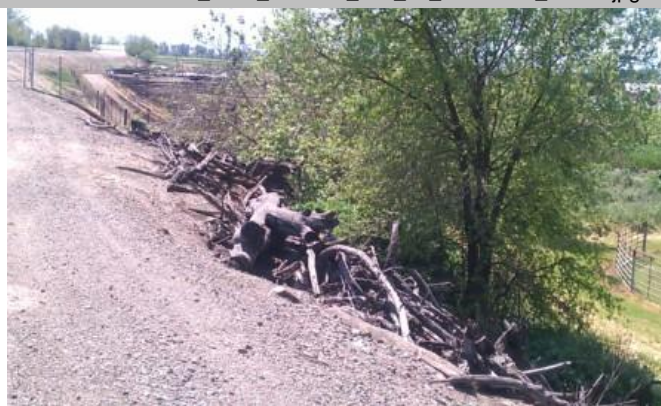
Photo 1 of 1 : SP_2017_RD0524_107_50_20170316_00094.jpg

LM Start	2.90	Rating **	U	Issue No.	50
LM End	2.92	Issue Type +	Ma	Location *	LS
Category	Earthen Levee			GPS Latitude/Longitude	
				Start	End
Item	Encroachments			37.913767 °	37.913503 °
				-121.324427 °	-121.324488 °
DWR ID	DWR_RD0524_01_s_2012_50				
Comment Code					
PR : Prunings					
Inspector Comment

Looking southwest at prunings on landside slope.

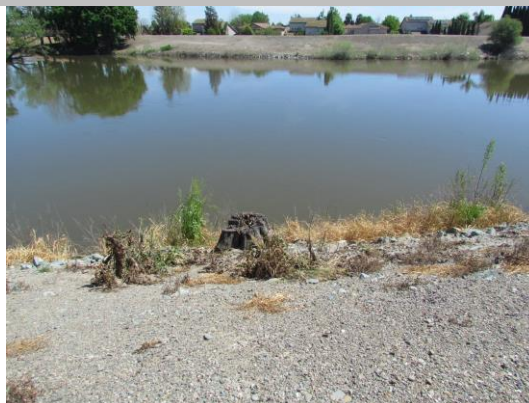
Photo 1 of 1 : SP_2017_RD0524_107_161_20170407_00388.jpg

LM Start	2.91	Rating **	U	Issue No.	161
LM End	2.91	Issue Type +	Ma	Location *	WS
Category	Earthen Levee			GPS Latitude/Longitude	
				Start	End
Item	Trim / Thin Trees			37.913733 °	37.913733 °
				-121.324398 °	-121.324398 °
DWR ID	DWR_RD0524_01_s_2017_161				
Comment Code					
T5 : Tree stumps.					
Inspector Comment

Looking east at large tree stump on waterward shoulder.

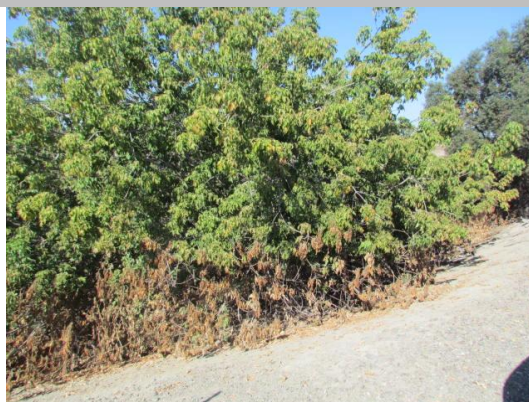
Photo 1 of 2 : SP_2017_RD0524_107_51_20170316_00095.jpg

LM Start	2.93	Rating **	U	Issue No.	51
LM End	2.93	Issue Type +	Ma	Location *	LS
Category	Earthen Levee			GPS Latitude/Longitude	
				Start	End
Item	Trim / Thin Trees			37.913415 °	37.913415 °
				-121.324503 °	-121.324503 °
DWR ID	DWR_RD0524_01_s_2012_51				
Comment Code					
T1 : Trim trees to at least five feet above ground level.					
Inspector Comment					
Untrimmed trees on landward slope and toe.

Looking south at dense trees on landward slope fall 2015

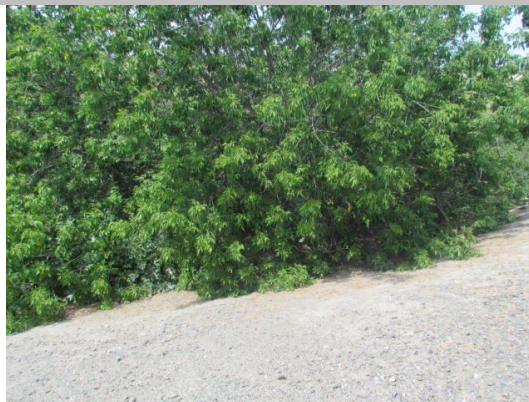
Photo 2 of 2 : SP_2017_RD0524_107_51_20170316_00096.jpg

Looking south at dense trees on landward slope spring 2015

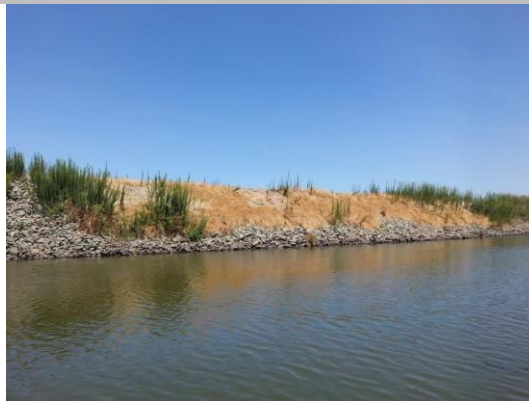
Photo 1 of 2 : SP_2017_RD0524_107_126_20170316_00184.jpg

LM Start	2.96	Rating **	U	Issue No.	126
LM End	2.96	Issue Type +	Ma	Location *	WS
Category	Supplemental			GPS Latitude/Longitude	
				Start	End
Item	DWR Erosion Survey			37.913010 °	37.913010 °
				-121.324490 °	-121.324490 °
DWR ID	DWR_RD0524_01_s_2017_126				
Comment Code					
Inspector Comment					
07/25/2016: No significant change observed.					
06/24/2015: No significant change observed.					
06/19/2014: No significant change observed.					
08/13/2013: No significant change observed.					
08/07/2012: The site was first reported in 2012 spring levee inspection report. [2016 Site ID:RD0524U01RM43.52]

Upstream view of the erosion.

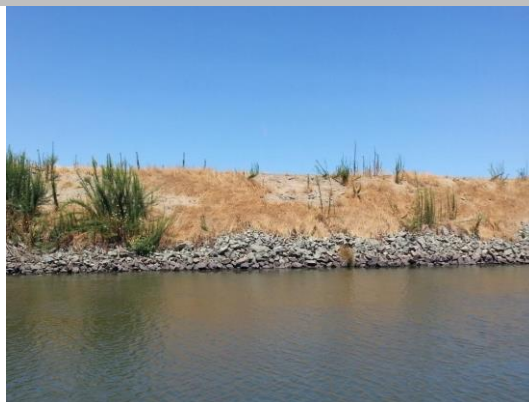
Photo 2 of 2 : SP_2017_RD0524_107_126_20170316_00185.jpg

Close view of the erosion. Note the vegetation at the site.

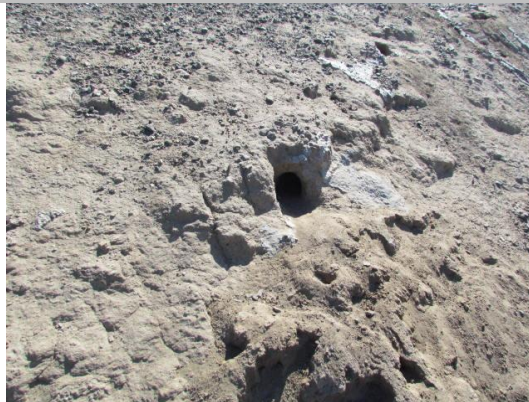
Photo 1 of 2 : SP_2017_RD0524_107_925_20170316_00279.jpg

LM Start	3.07	Rating **	M	Issue No.	925
LM End	3.27	Issue Type +	Ma	Location *	LS
Category	Earthen Levee			GPS Latitude/Longitude	
				Start	End
Item	Animal Control			37.911382 °	37.908602 °
				-121.324928 °	-121.325395 °
DWR ID	DWR_RD0524_01_s _ 2012_925				
Comment Code					
A1 : Exterminate rodents and backfill and compact or grout burrows.					
Inspector Comment					
Several rodent holes on levee slopes.

Looking at typical view of rodent hole with this section fall 2015.

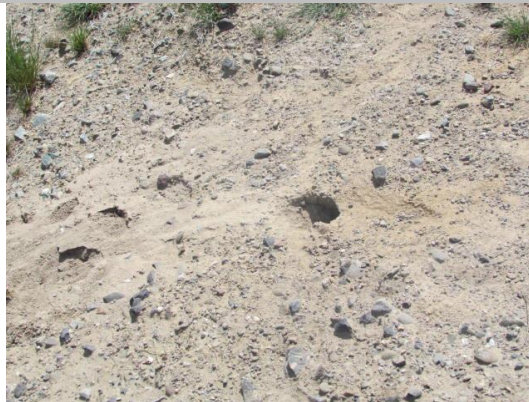
Photo 2 of 2 : SP_2017_RD0524_107_925_20170316_00280.jpg

Looking at typical rodent holes on landward slope along this reach.

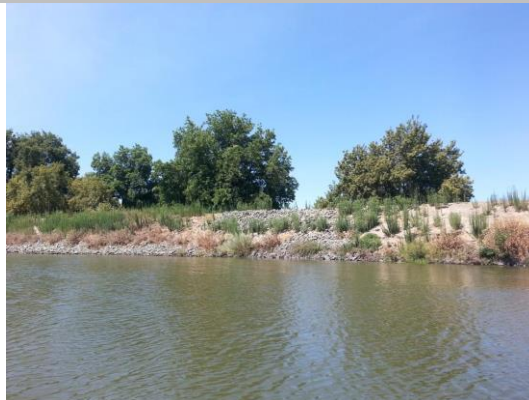
Photo 1 of 1 : SP_2017_RD0524_107_129_20170316_00186.jpg

LM Start	3.30	Rating **	U	Issue No.	129
LM End	3.32	Issue Type +	Ma	Location *	WS
Category	Supplemental			GPS Latitude/Longitude	
				Start	End
Item	DWR Erosion Survey			37.908090 °	37.908090 °
				-121.325090 °	-121.325090 °
DWR ID	DWR_RD0524_01_s_2017_129				
Comment Code					
Inspector Comment					
07/25/2016: No significant change observed.					
06/24/2015: No significant change observed.					
06/19/2014: No significant change observed.					
08/13/2013: The levee toe seems to have been protected by river rocks and vegetation on site. [2016 Site ID:RD0524U01RM43.86]

Close view of the erosion. Note the river rocks and vegetation at the levee toe.

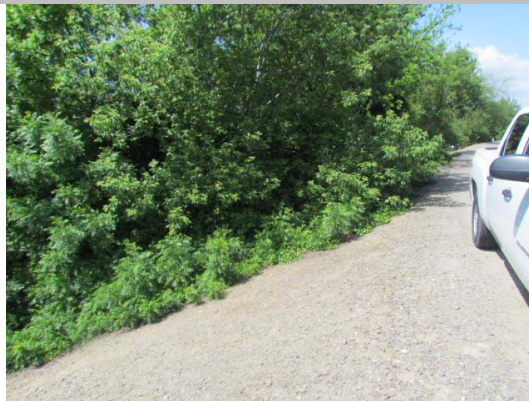
Photo 1 of 2 : SP_2017_RD0524_107_926_20170316_00281.jpg

LM Start	3.30	Rating **	U	Issue No.	926
LM End	3.38	Issue Type +	Ma	Location *	LS
Category	Earthen Levee			GPS Latitude/Longitude	
				Start	End
Item	Trim / Thin Trees			37.908158 °	37.907080 °
				-121.325418 °	-121.325366 °
DWR ID	DWR_RD0524_01_s_2012_926				
Comment Code					
T1 : Trim trees to at least five feet above ground level.					
Inspector Comment

Looking southwest at dense veg on landward slope.

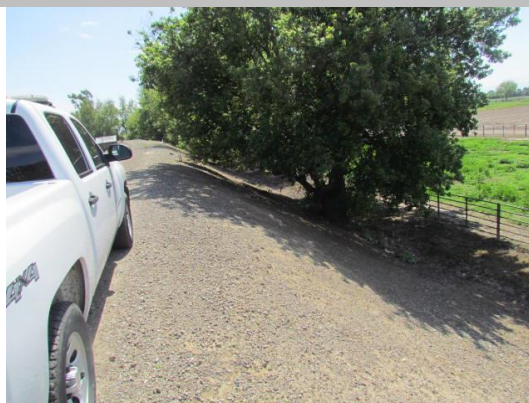
Photo 2 of 2 : SP_2017_RD0524_107_926_20170316_00282.jpg

Looking at untrimmed trees on landward slope and toe.

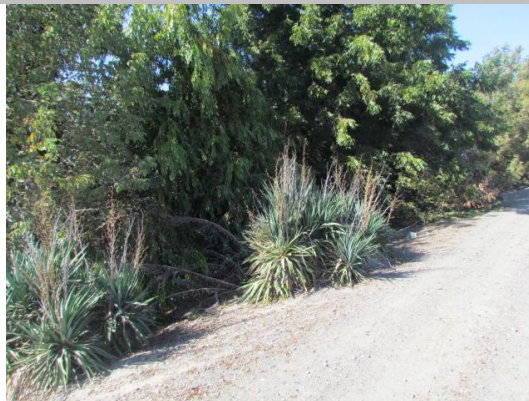
Photo 1 of 1 : SP_2017_RD0524_107_54_20170316_00098.jpg

LM Start	3.45	Rating **	U	Issue No.	54
LM End	3.45	Issue Type +	Ma	Location *	LS
Category	Earthen Levee			GPS Latitude/Longitude	
				Start	End
Item	Trim / Thin Trees			37.906227 °	37.906227 °
				-121.324683 °	-121.324683 °
DWR ID	DWR_RD0524_01_s_2012_54				
Comment Code					
T3 : Trim and thin trees to allow visibility of the ground and room to flood fight.					
Inspector Comment					
Dense untrimmed trees on landward slope.

Looking northwest at dense vegetation on landside slope.

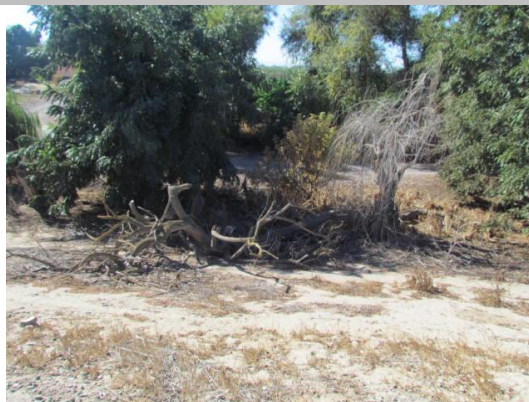
Photo 1 of 1 : SP_2017_RD0524_107_177_20170316_00210.jpg

LM Start	3.48	Rating **	M	Issue No.	177
LM End	3.48	Issue Type +	Ma	Location *	LS
Category	Earthen Levee			GPS Latitude/Longitude	
				Start	End
Item	Encroachments			37.905994 °	37.905994 °
				-121.324194 °	-121.324194 °
DWR ID	DWR_RD0524_01_f_2014_177				
Comment Code					
TR : Tree or limb					
Inspector Comment					
Dead tree on landward toe.

Looking at dead tree limb at landward toe fall 2015.

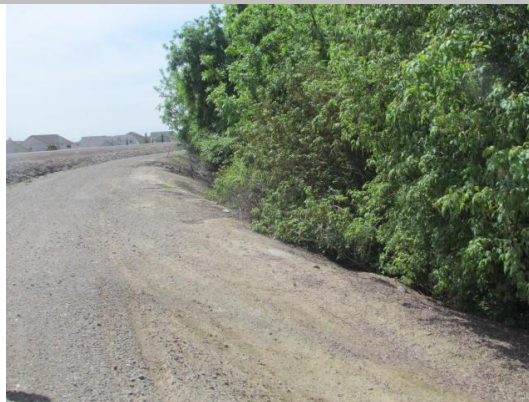
Photo 1 of 1 : SP_2017_RD0524_107_57_20170316_00102.jpg

LM Start	3.51	Rating **	U	Issue No.	57
LM End	3.61	Issue Type +	Ma	Location *	LS
Category	Earthen Levee			GPS Latitude/Longitude	
				Start	End
Item	Trim / Thin Trees			37.905638 °	37.904430 °
				-121.323892 °	-121.324570 °
DWR ID	DWR_RD0524_01_s_2012_57				
Comment Code					
T3 : Trim and thin trees to allow visibility of the ground and room to flood fight.					
Inspector Comment

Looking south at dense trees on landward slope.

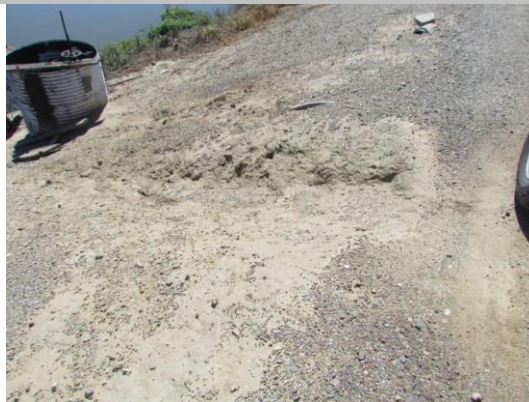
Photo 1 of 2 : SP_2017_RD0524_107_58_20170407_00389.jpg

LM Start	3.64	Rating **	M	Issue No.	58
LM End	3.64	Issue Type +	Ma	Location *	WS
Category	Earthen Levee			GPS Latitude/Longitude	
				Start	End
Item	Slope Stability			37.904113 °	37.904113 °
				-121.325080 °	-121.325080 °
DWR ID	DWR_RD0524_01_s_2012_58				
Comment Code					
S2 : Repair the levee slope damaged by foot traffic and prevent access where possible.					
Inspector Comment					
Landowner cut steps into waterside slope.					
4/3/17: Steps washed away slope damage remains.

Looking south at step cut into waterward slope. (Spring 2017)

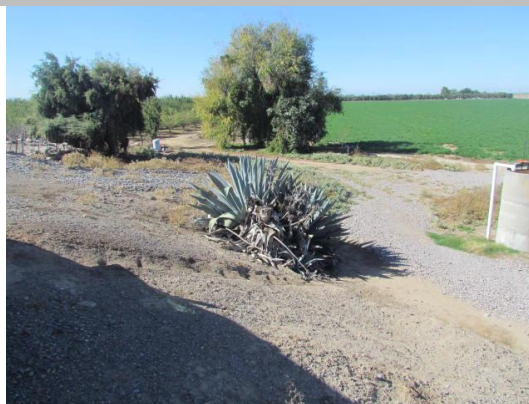
Photo 1 of 1 : SP_2017_RD0524_107_190_20170316_00222.jpg

LM Start	3.65	Rating **	U	Issue No.	190
LM End	3.65	Issue Type +	Ma	Location *	LS
Category	Earthen Levee			GPS Latitude/Longitude	
				Start	End
Item	Vegetation			37.904070 °	37.904070 °
				-121.325118 °	-121.325118 °
DWR ID	DWR_RD0524_01_f_2015_190				
Comment Code					
V2 : Remove the wild growth other than native grasses from the levee slopes.					
Inspector Comment					
Large century plant at landward toe.

Looking southwest at century plant at landward toe fall 2015.

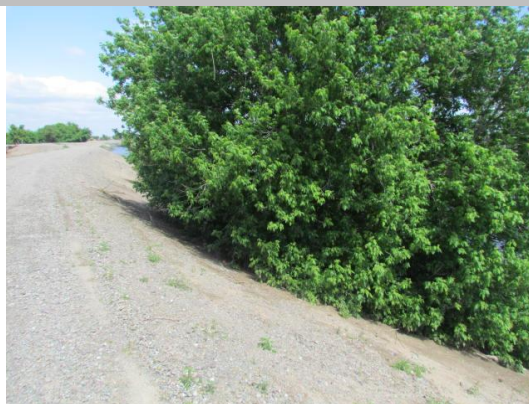
Photo 1 of 1 : SP_2017_RD0524_107_52_20170316_00097.jpg

LM Start	3.75	Rating **	U	Issue No.	52
LM End	3.75	Issue Type +	Ma	Location *	WS
Category	Earthen Levee			GPS Latitude/Longitude	
				Start	End
Item	Trim / Thin Trees			37.902828 °	37.902828 °
				-121.326170 °	-121.326170 °
DWR ID	DWR_RD0524_01_s_2016_52				
Comment Code					
T1 : Trim trees to at least five feet above ground level.					
Inspector Comment

Looking south at untrimmed tree on landward slope and toe.

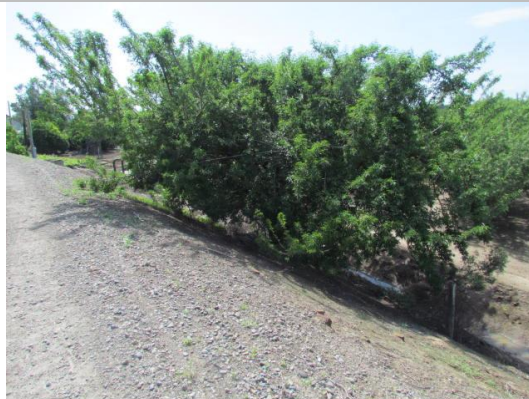
Photo 1 of 1 : SP_2017_RD0524_107_927_20170316_00283.jpg

LM Start	3.77	Rating **	U	Issue No.	927
LM End	3.77	Issue Type +	Ma	Location *	LS
Category	Earthen Levee			GPS Latitude/Longitude	
				Start	End
Item	Trim / Thin Trees			37.902645 °	37.902645 °
				-121.326340 °	-121.326340 °
DWR ID	DWR_RD0524_01_s _ 2012_927				
Comment Code					
T1 : Trim trees to at least five feet above ground level.					
Inspector Comment					
Untrimmed almond tree on landward slope.

Looking southwest at untrimmed tree at landward toe.

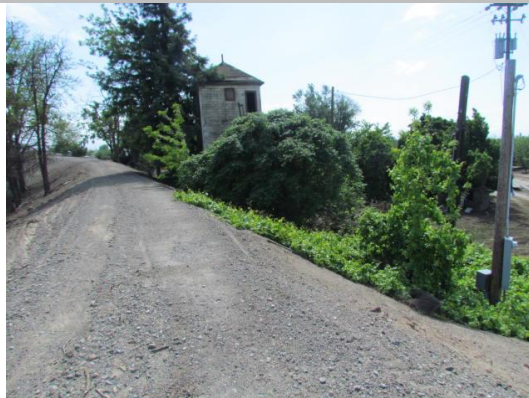
Photo 1 of 1 : SP_2017_RD0524_107_59_20170316_00104.jpg

LM Start	3.78	Rating **	U	Issue No.	59
LM End	3.78	Issue Type +	Ma	Location *	LS
Category	Earthen Levee			GPS Latitude/Longitude	
				Start	End
Item	Trim / Thin Trees			37.902417 °	37.902417 °
				-121.326482 °	-121.326482 °
DWR ID	DWR_RD0524_01_s _ 2012_59				
Comment Code					
T1 : Trim trees to at least five feet above ground level.					
Inspector Comment

Looking south at dense veg on landward slope and toe.

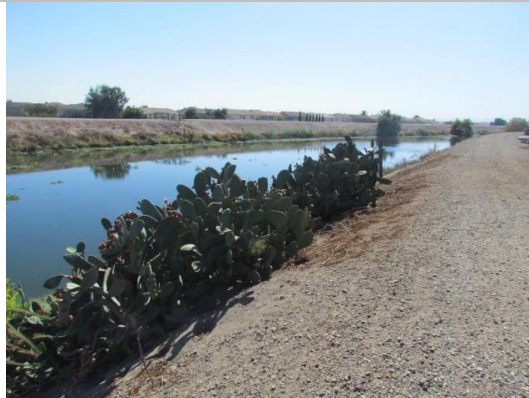
Photo 1 of 2 : SP_2017_RD0524_107_94_20170316_00152.jpg

LM Start	3.88	Rating **	U	Issue No.	94
LM End	3.88	Issue Type +	Ma	Location *	WS
Category	Earthen Levee			GPS Latitude/Longitude	
				Start	End
Item	Vegetation			37.900952 °	37.900952 °
				-121.326443 °	-121.326443 °
DWR ID	DWR_RD0524_01_s _ 2012_94				
Comment Code					
V2 : Remove the wild growth other than native grasses from the levee slopes.					
Inspector Comment					
Remove cactus from waterward slope.

Looking southeast at cactus on waterward slope fall 2015

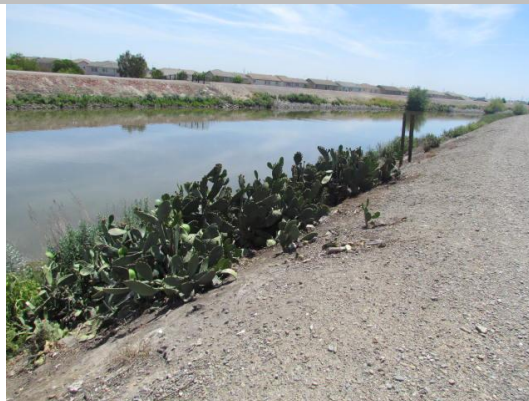
Photo 2 of 2 : SP_2017_RD0524_107_94_20170316_00153.jpg

LM Start	3.88	Rating **	U	Issue No.	94 (cont)	
LM End	3.88	Issue Type +	Ma	Location *	WS	
Category	Earthen Levee			GPS Latitude/Longitude		
				Start		End
Item	Vegetation			37.900952 °		37.900952 °
				-121.326443 °		-121.326443 °
DWR ID	DWR_RD0524_01_s_2012_94					
Comment Code						
V2 : Remove the wild growth other than native grasses from the levee slopes.						
Inspector Comment						
Remove cactus from waterward slope.

Looking southeast at cactus on waterside slope. Fall 2013

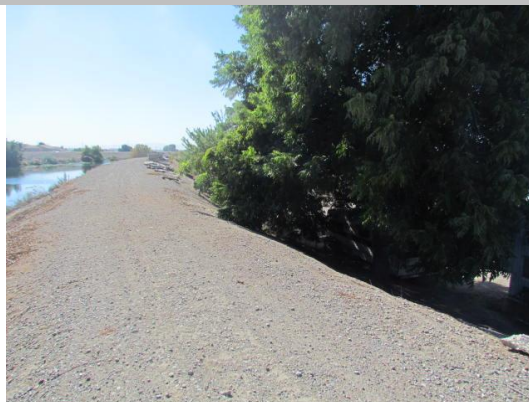
Photo 1 of 1 : SP_2017_RD0524_107_83_20170316_00137.jpg

LM Start	3.89	Rating **	U	Issue No.	83
LM End	3.89	Issue Type +	Ma	Location *	LS
Category	Earthen Levee			GPS Latitude/Longitude	
				Start	End
Item	Trim / Thin Trees			37.900854 °	37.900854 °
				-121.326438 °	-121.326438 °
DWR ID	DWR_RD0524_01_s_2012_83				
Comment Code					
T1 : Trim trees to at least five feet above ground level.					
Inspector Comment					
Untrimmed tree on landward slope.

Looking south at untrimmed trees on landward slope and toe.

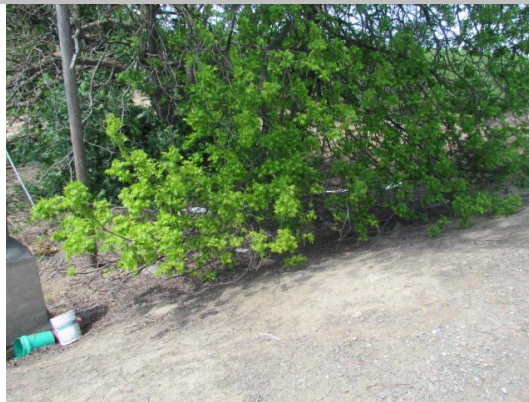
Photo 1 of 1 : SP_2017_RD0524_107_61_20170316_00108.jpg

LM Start	4.03	Rating **	M	Issue No.	61
LM End	4.03	Issue Type +	Ma	Location *	LS
Category	Earthen Levee			GPS Latitude/Longitude	
				Start	End
Item	Trim / Thin Trees			37.898925 °	37.898925 °
				-121.327015 °	-121.327015 °
DWR ID	DWR_RD0524_01_s_2012_61				
Comment Code					
T1 : Trim trees to at least five feet above ground level.					
Inspector Comment

Looking east at untrimmed tree at landward toe.

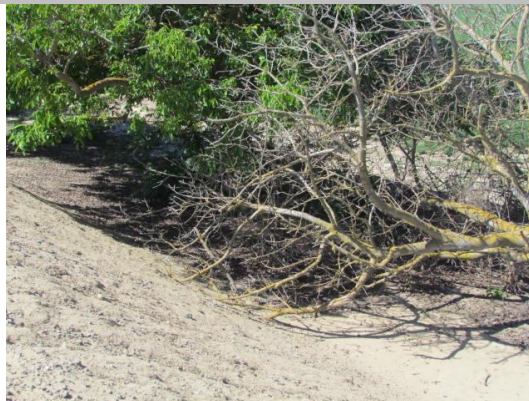
Photo 1 of 1 : SP_2017_RD0524_107_111_20170316_00170.jpg

LM Start	4.38	Rating **	M	Issue No.	111
LM End	4.38	Issue Type +	Ma	Location *	LS
Category	Earthen Levee			GPS Latitude/Longitude	
				Start	End
Item	Encroachments			37.894258 °	37.894258 °
				-121.329247 °	-121.329247 °
DWR ID	DWR_RD0524_01_s_2012_111				
Comment Code					
TR : Tree or limb					
Inspector Comment					
Dead tree at landside toe should be removed from levee toe.

Looking west at dead tree at landside toe.

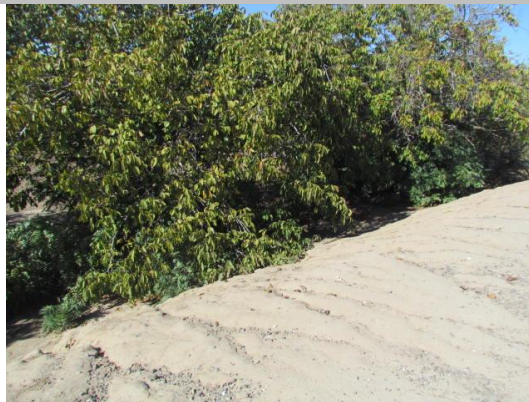
Photo 1 of 2 : SP_2017_RD0524_107_112_20170316_00171.jpg

LM Start	4.40	Rating **	U	Issue No.	112
LM End	4.53	Issue Type +	Ma	Location *	LS
Category	Earthen Levee			GPS Latitude/Longitude	
				Start	End
Item	Trim / Thin Trees			37.893928 °	37.892230 °
				-121.329203 °	-121.328187 °
DWR ID	DWR_RD0524_01_s_2012_112				
Comment Code					
T1 : Trim trees to at least five feet above ground level.					
Inspector Comment					
Untrimmed trees along landward slope and toe.

Looking northeast at untrimmed tree on landward slope and toe fall 2015.

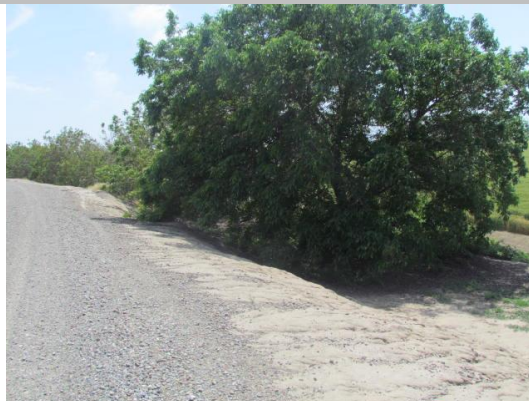
Photo 2 of 2 : SP_2017_RD0524_107_112_20170316_00172.jpg

LM Start	4.40	Rating **	U	Issue No.	112 (cont)	
LM End	4.53	Issue Type +	Ma	Location *	LS	
Category	Earthen Levee			GPS Latitude/Longitude		
				Start		End
Item	Trim / Thin Trees			37.893928 °	37.892230 °	
				-121.329203 °	-121.328187 °	
DWR ID	DWR_RD0524_01_s_2012_112					
Comment Code						
T1 : Trim trees to at least five feet above ground level.						
Inspector Comment						
Untrimmed trees along landward slope and toe.

Looking southeast at untrimmed tree at landward toe.

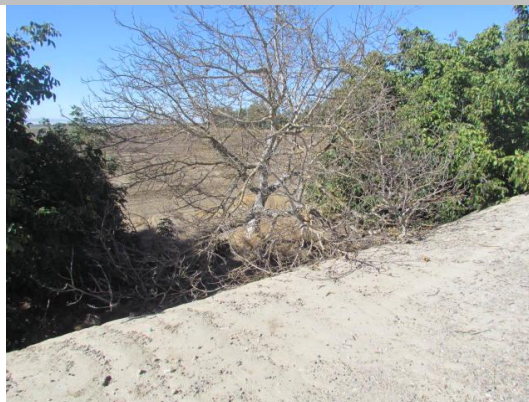
Photo 1 of 1 : SP_2017_RD0524_107_199_20170316_00230.jpg

LM Start	4.43	Rating **	U	Issue No.	199
LM End	4.43	Issue Type +	Ma	Location *	LS
Category	Earthen Levee			GPS Latitude/Longitude	
				Start	End
Item	Encroachments			37.893582 °	37.893582 °
				-121.329108 °	-121.329108 °
DWR ID	DWR_RD0524_01_f_2015_199				
Comment Code					
TR : Tree or limb					
Inspector Comment					
Remove dead tree from landward toe.

Looking west at dead tree on landward slope and toe fall 2015.

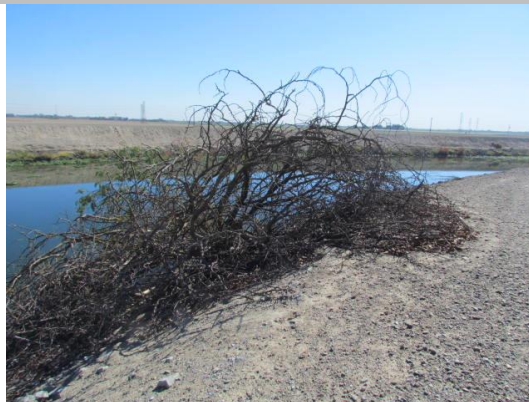
Photo 1 of 2 : SP_2017_RD0524_107_102_20170316_00162.jpg

LM Start	4.52	Rating **	U	Issue No.	102
LM End	4.52	Issue Type +	Ma	Location *	WS
Category	Earthen Levee			GPS Latitude/Longitude	
				Start	End
Item	Encroachments			37.892368 °	37.892368 °
				-121.328200 °	-121.328200 °
DWR ID	DWR_RD0524_01_f_2016_102				
Comment Code					
TR : Tree or limb					
Inspector Comment					
Dead tree on waterward slope.

Looking southeast at dead tree on waterside slope fall 2015

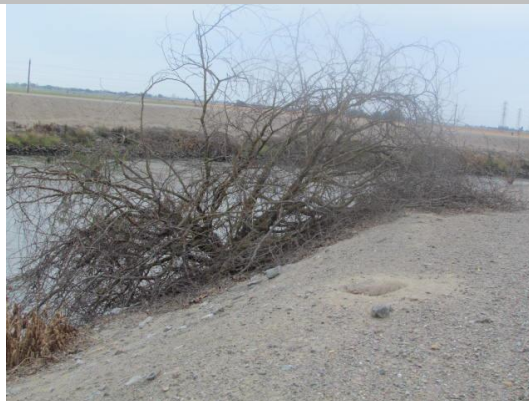
Photo 2 of 2 : SP_2017_RD0524_107_102_20170316_00163.jpg

LM Start	4.52	Rating **	U	Issue No.	102 (cont)	
LM End	4.52	Issue Type +	Ma	Location *	WS	
Category	Earthen Levee			GPS Latitude/Longitude		
				Start		End
Item	Encroachments			37.892368 °		37.892368 °
				-121.328200 °		-121.328200 °
DWR ID	DWR_RD0524_01_f_2016_102					
Comment Code						
TR : Tree or limb						
Inspector Comment						
Dead tree on waterward slope.

Looking southeast at dead tree on waterside slope.

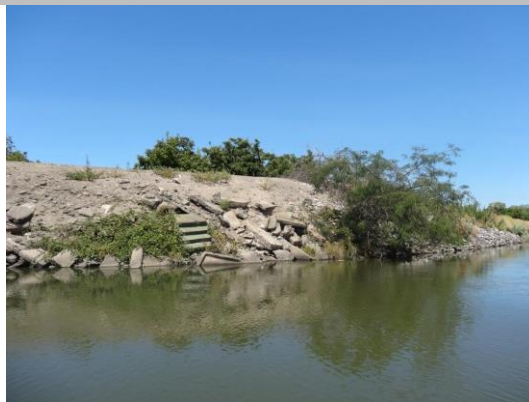
Photo 1 of 2 : SP_2017_RD0524_107_132_20170316_00187.jpg

LM Start	4.53	Rating **	U	Issue No.	132
LM End	4.54	Issue Type +	Ma	Location *	WS
Category	Supplemental			GPS Latitude/Longitude	
				Start	End
Item	DWR Erosion Survey			37.892230 °	37.892230 °
				-121.327930 °	-121.327930 °
DWR ID	DWR_RD0524_01_s_2017_132				
Comment Code					
Inspector Comment					
07/25/2016: No significant change observed.					
06/24/2015: No significant change observed.					
06/19/2014: No significant change observed.					
08/13/2013: No significant change observed.					
08/07/2012: The erosion is located at the inside of a river bend. Site is covered with broken concrete blocks and other debris. [2016 Site ID:RD0524U01RM45.07]

Front view of the site. Note the loosely placed concrete blocks at the site.

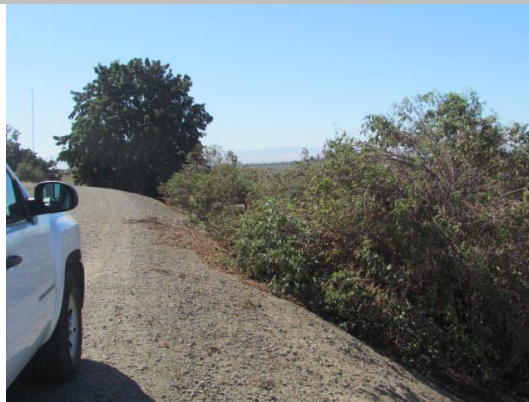
Photo 1 of 1 : SP_2017_RD0524_107_114_20170316_00174.jpg

LM Start	4.96	Rating **	U	Issue No.	114
LM End	4.98	Issue Type +	Ma	Location *	LS
Category	Earthen Levee			GPS Latitude/Longitude	
				Start	End
Item	Vegetation			37.886907 °	37.886673 °
				-121.331862 °	-121.331965 °
DWR ID	DWR_RD0524_01_s_2012_114				
Comment Code					
V4 : Elderberries are blocking visibility and flood fight capability.					
Inspector Comment					
Dense elderberry on landward slope.

Looking southwest at dense elderberry bush on landward slope and toe fall 2015.

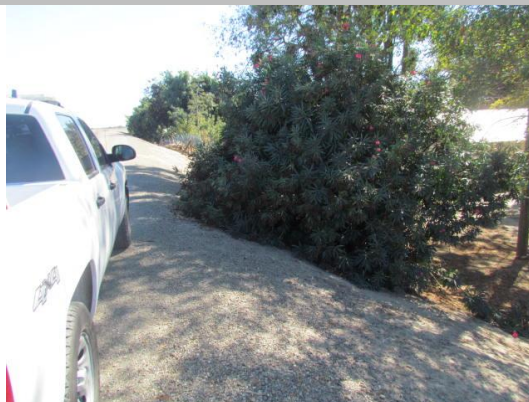
Photo 1 of 1 : SP_2017_RD0524_107_188_20170316_00221.jpg

LM Start	5.05	Rating **	U	Issue No.	188
LM End	5.17	Issue Type +	Ma	Location *	LS
Category	Earthen Levee			GPS Latitude/Longitude	
				Start	End
Item	Trim / Thin Trees			37.885617 °	37.883938 °
				-121.332143 °	-121.332130 °
DWR ID	DWR_RD0524_01_s_2014_188				
Comment Code					
T1 : Trim trees to at least five feet above ground level.					
Inspector Comment					
Untrimmed trees on landward slope and toe.

Looking south at oleander on landward slope.

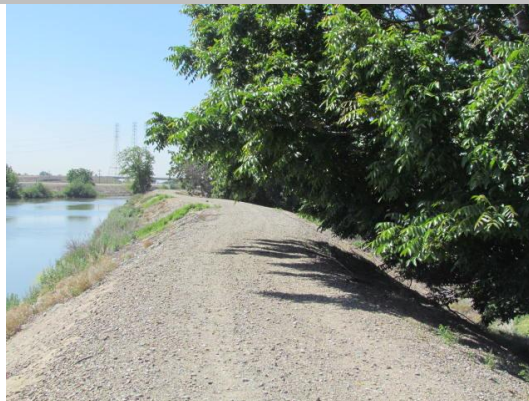
Photo 1 of 1 : SP_2017_RD0524_107_68_20170316_00112.jpg

LM Start	5.07	Rating **	U	Issue No.	68
LM End	5.07	Issue Type +	Ma	Location *	LS
Category	Earthen Levee			GPS Latitude/Longitude	
				Start	End
Item	Trim / Thin Trees			37.885400 °	37.885400 °
				-121.332153 °	-121.332153 °
DWR ID	DWR_RD0524_01_s_2012_68				
Comment Code					
T4 : Trim trees over roadway to at least 12 feet above ground level.					
Inspector Comment

Looking south at overhanging trees.

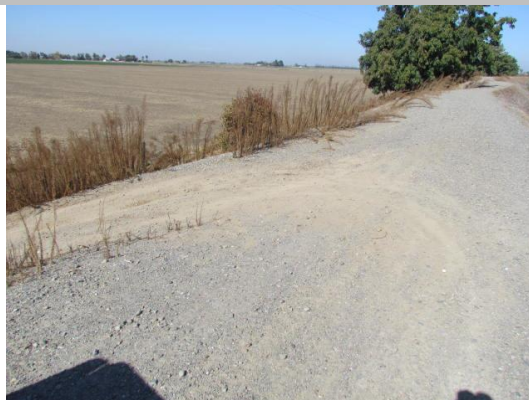
Photo 1 of 1 : SP_2017_RD0524_107_115_20170316_00175.jpg

LM Start	5.19	Rating **	M	Issue No.	115
LM End	5.19	Issue Type +	Ma	Location *	LS
Category	Earthen Levee			GPS Latitude/Longitude	
				Start	End
Item	Slope Stability			37.883587 °	37.883587 °
				-121.332100 °	-121.332100 °
DWR ID	DWR_RD0524_01_s_2012_115				
Comment Code					
S3 : Repair the levee slope damaged by vehicle traffic and prevent access where possible.					
Inspector Comment					
Vehicle traffic created a ramp on landward slope.

Looking northwest at slope damage on landward slope.

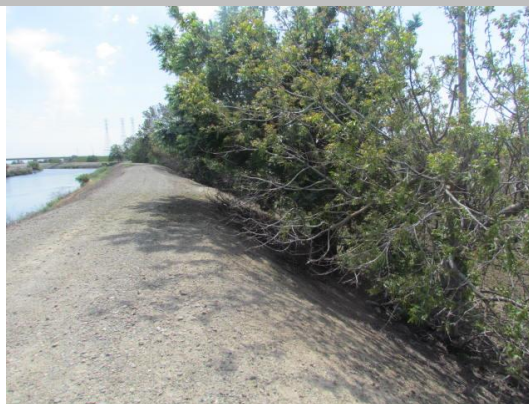
Photo 1 of 1 : SP_2017_RD0524_107_85_20170316_00139.jpg

LM Start	5.28	Rating **	U	Issue No.	85
LM End	5.34	Issue Type +	Ma	Location *	LS
Category	Earthen Levee			GPS Latitude/Longitude	
				Start	End
Item	Trim / Thin Trees			37.882377 °	37.881498 °
				-121.332598 °	-121.332800 °
DWR ID	DWR_RD0524_01_s_2012_85				
Comment Code					
T1 : Trim trees to at least five feet above ground level.					
Inspector Comment

Looking south at untrimmed trees on landward slope.

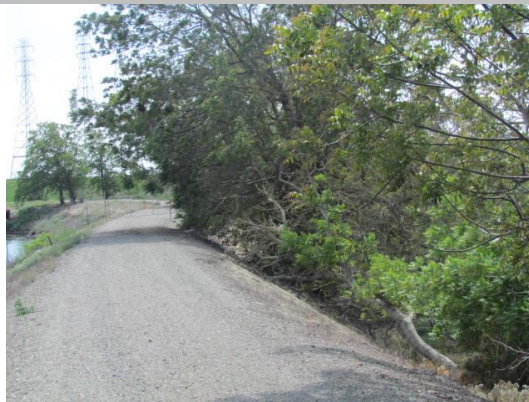
Photo 1 of 1 : SP_2017_RD0524_107_932_20170316_00285.jpg

LM Start	5.38	Rating **	U	Issue No.	932
LM End	5.41	Issue Type +	Ma	Location *	LS
Category	Earthen Levee			GPS Latitude/Longitude	
				Start	End
Item	Trim / Thin Trees			37.880945 °	37.880522 °
				-121.332837 °	-121.332918 °
DWR ID	DWR_RD0524_01_s_2012_932				
Comment Code					
T1 : Trim trees to at least five feet above ground level.					
Inspector Comment

Looking south at untrimmed trees on landward slope and toe.

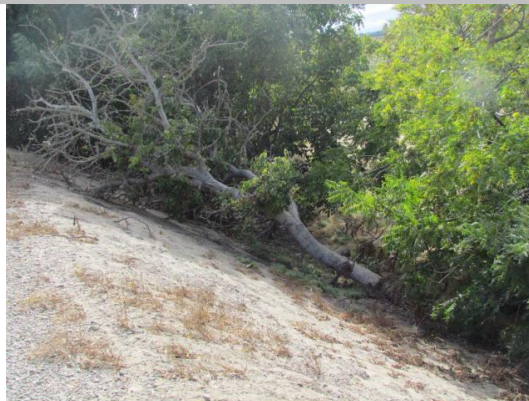
Photo 1 of 1 : SP_2017_RD0524_107_178_20170316_00211.jpg

LM Start	5.39	Rating **	M	Issue No.	178
LM End	5.39	Issue Type +	Ma	Location *	LS
Category	Earthen Levee			GPS Latitude/Longitude	
				Start	End
Item	Encroachments			37.880806 °	37.880806 °
				-121.332833 °	-121.332833 °
DWR ID	DWR_RD0524_01_f_2014_178				
Comment Code					
TR : Tree or limb					
Inspector Comment					
Downed tree on landward toe.

Looking south at downed tree on landward slope.

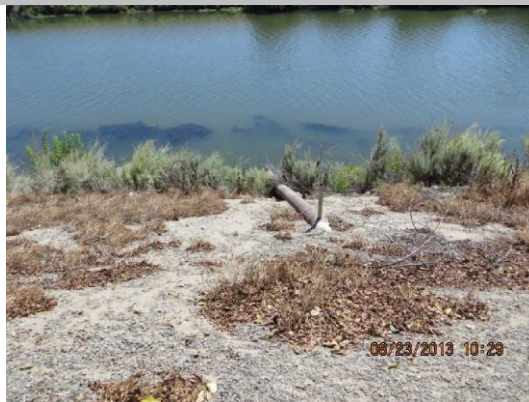
Photo 1 of 3 : UCIP_SP_2017_51633_30689.jpg

LM Start	5.41	Rating **	U	Issue No.	963
LM End	5.41	Issue Type +	Ma	Location *	LS
Category	Supplemental			GPS Latitude/Longitude	
				Start	End
Item	DWR UCIP LMA Responsibility			37.880584 °	37.880584 °
				-121.332901 °	-121.332901 °
DWR ID

Comment Code					
Inspector Comment					
FS_ID:51633 DS_ID:20630 EP_NO: N/A Repair Type: Urgent Crossing Status: Found UCIP Comments: 11/16/2016 same as previous inspection hole in pipe is still present on WS near toe. This pipe does not appear to be in use. Need to contact owner to determine status of crossing. If the crossing is abandoned or still in use, owner will need to coordinate with the CVFPB to comply with Title 23 requirements. (O. Magana - DWR UCIP)08/23/2013 flap gate damage and does not work at WS toe. Large hole in pipe at WS toe. Pipe appears abandoned and should be done so properly. (W. Wylie - DWR UCIP) FIELD_STRUCT_DESC: *ABANDONED* 1 of 2: 12-inch steel irrigation pipe (O&M references 10-inch pipe) through the levee, 6 feet below the crown. Pump located on waterside (WS), no pump found in 2013. Flap gate located on the WS end. [Additional Reference(s): DWR Levee Log, 2004. USACE San Joaquin River O&M Unit No. 7, April 1964, (HLM 5.48), Drawing No. 07-04-1490, sheet 1490/4, station 8+01.3] FS Date: 11/16/2016

Pipe visible on WS slope.

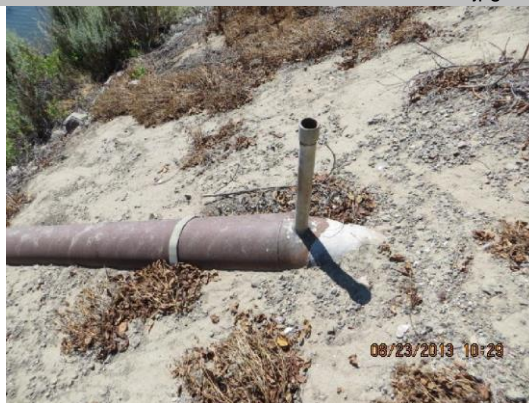
Photo 2 of 3 : UCIP_SP_2017_51633_30688.jpg

FS_ID:51633
DS_ID:20630
EP_NO: N/A
Repair Type: Urgent
Crossing Status: Found
UCIP Comments: 11/16/2016 same as previous inspection hole in pipe is still present on WS near toe. This pipe does not appear to be in use. Need to contact owner to determine status of crossing. If the crossing is abandoned or still in use, owner will need to coordinate with the CVFPB to comply with Title 23 requirements. (O. Magana - DWR UCIP)08/23/2013 flap gate damage and does not work at WS toe.
Large hole in pipe at WS toe. Pipe appears abandoned and should be done so properly. (W. Wylie - DWR UCIP)
FIELD_STRUCT_DESC: *ABANDONED* 1 of 2: 12-inch steel irrigation pipe (O&M references 10-inch pipe) through the levee, 6 feet below the crown. Pump located on waterside (WS), no pump found in 2013. Flap gate located on the WS end. [Additional Reference(s): DWR Levee Log, 2004. USACE San Joaquin River O&M Unit No. 7, April 1964, (HLM 5.48), Drawing No. 07-04-1490, sheet 1490/4, station 8+01.3]

Vent on pipe on WS slope. Possible slurry standpipe that has not yet been used.

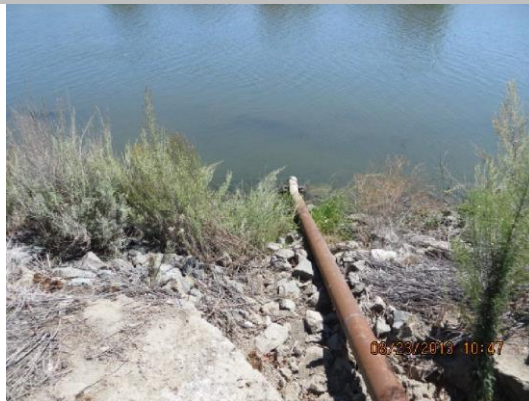
Photo 3 of 3 : UCIP_SP_2017_18348_30704.jpg

LM Start	5.42	Rating **	M	Issue No.	964 (cont)
LM End	5.42	Issue Type +	Ma	Location *	LS
Category	Supplemental			GPS Latitude/Longitude	
				Start	End
Item	DWR UCIP LMA Responsibility			37.880358 °	37.880358 °
				-121.332972 °	-121.332972 °
DWR ID					
Comment Code					
Inspector Comment					
FS_ID:18348 DS_ID:20631 EP_NO: N/A Repair Type: Non-Urgent Crossing Status: Found UCIP Comments: Recent work being done on WS slope. Pipe may still be in use. FIELD_STRUCT_DESC: 10-inch steel storm drain pipe through the levee 6.0 feet below the crown. Pump not found on LS. Originally included in the 1964 O&M manual. FS Date: 8/23/2013

No flap gate on end of pipe at WS toe.

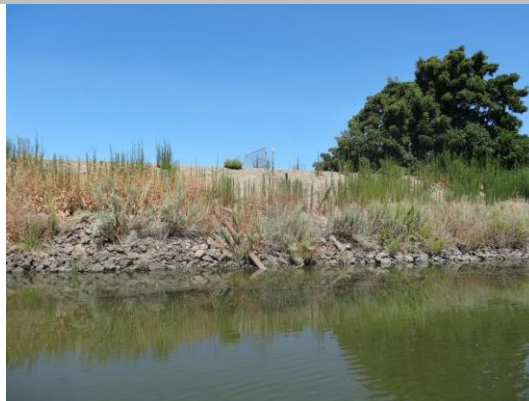
Photo 1 of 2 : SP_2017_RD0524_107_134_20170316_00189.jpg

LM Start	5.43	Rating **	U	Issue No.	134
LM End	5.43	Issue Type +	Ma	Location *	WS
Category	Supplemental			GPS Latitude/Longitude	
				Start	End
Item	DWR Erosion Survey			37.880320 °	37.880320 °
				-121.333266 °	-121.333266 °
DWR ID	DWR_RD0524_01_s_2017_134				
Comment Code					
Inspector Comment					
07/25/2016: No significant change observed.					
06/24/2015: No significant change observed.					
06/19/2014: No significant change observed.					
08/13/2013: The erosion seems to be getting worse. More material sloughing visible.					
08/07/2012: The erosion is underneath an irrigation pipe. The likely cause of the erosion is the pipe leakage. [2016 Site ID:RD0524U01RM45.97]

Close view of the erosion and the pipe on the site.

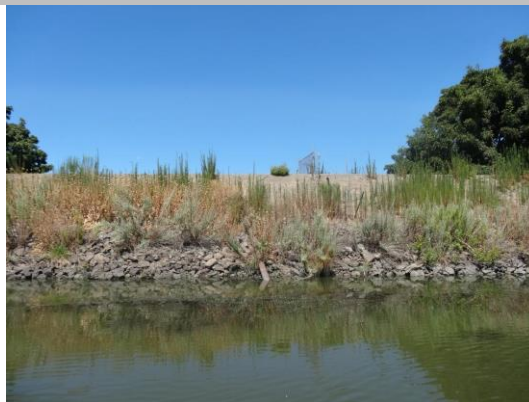
Photo 2 of 2 : SP_2017_RD0524_107_134_20170316_00190.jpg

LM Start	5.43	Rating **	U	Issue No.	134 (cont)
LM End	5.43	Issue Type +	Ma	Location *	WS

Front view of the site.

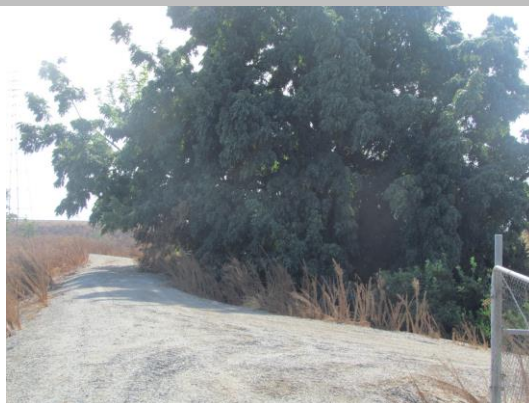
Photo 1 of 1 : SP_2017_RD0524_107_73_20170316_00118.jpg

LM Start	5.44	Rating **	U	Issue No.	73
LM End	5.44	Issue Type +	Ma	Location *	LS
Category	Earthen Levee			GPS Latitude/Longitude	
				Start	End
Item	Trim / Thin Trees			37.880085 °	37.880085 °
				-121.333045 °	-121.333045 °
DWR ID	DWR_RD0524_01_s_2012_73				
Comment Code					
T1 : Trim trees to at least five feet above ground level.					
Inspector Comment					
Untrimmed trees on landward slope.

Looking southwest at large untrimmed tree on landward slope.

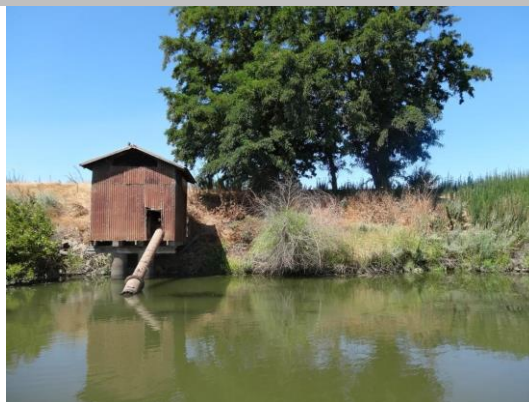
Photo 2 of 2 : SP_2017_RD0524_107_135_20170316_00192.jpg

LM Start	5.53	Rating **	M	Issue No.	135
LM End	5.53	Issue Type +	Ma	Location *	WS
Category	Supplemental			GPS Latitude/Longitude	
				Start	End
Item	DWR Erosion Survey			37.878920 °	37.878920 °
				-121.332670 °	-121.332670 °
DWR ID	DWR_RD0524_01_s_2017_135				
Comment Code					
Inspector Comment					
07/25/2016: No significant change observed.					
06/24/2015: No significant change observed.					
6/19/2014: No significant change observed.					
08/13/2013: Larger trees are at the levee shoulder, and an irrigation pump station is next to the erosion site. [2016 Site ID:RD0524U01RM46.06]

Close view of the erosion.

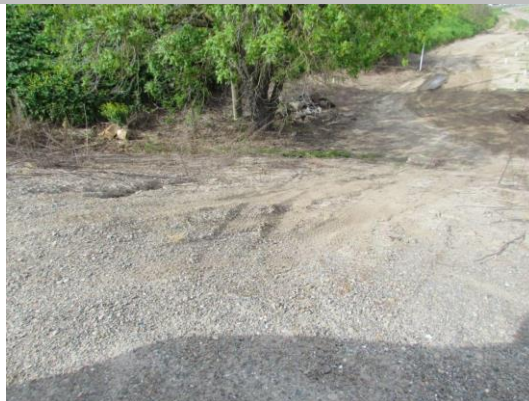
Photo 1 of 1 : SP_2017_RD0524_107_167_20170407_00393.jpg

LM Start	5.58	Rating **	M	Issue No.	167
LM End	5.58	Issue Type +	Ma	Location *	LS
Category	Earthen Levee			GPS Latitude/Longitude	
				Start	End
Item	Slope Stability			37.878115 °	37.878115 °
				-121.332763 °	-121.332763 °
DWR ID	DWR_RD0524_01_s_2017_167				
Comment Code					
S3 : Repair the levee slope damaged by vehicle traffic and prevent access where possible.					
Inspector Comment					
Slope damage caused by vehicle traffic.

Looking west at slope damage caused by vehicle traffic on landward slope.

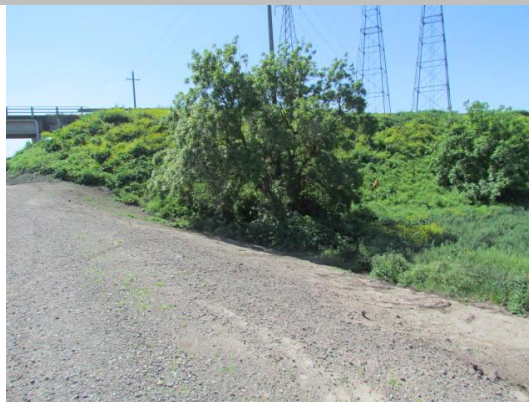
Photo 1 of 2 : SP_2017_RD0524_107_214_20170316_00248.jpg

LM Start	5.58	Rating **	U	Issue No.	214
LM End	5.58	Issue Type +	Ma	Location *	LS
Category	Earthen Levee			GPS Latitude/Longitude	
				Start	End
Item	Vegetation			37.878083 °	37.878083 °
				-121.332717 °	-121.332717 °
DWR ID	DWR_RD0524_01_s_2016_214				
Comment Code					
V2 : Remove the wild growth other than native grasses from the levee slopes.					
Inspector Comment					
Tall weeds, grasses and trees blocking view of landward toe.

Looking west at dense veg at landward toe.

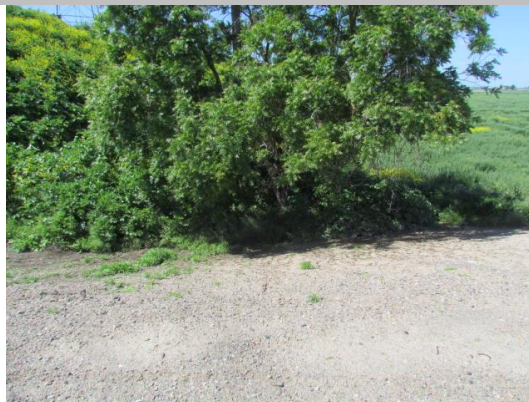
Photo 2 of 2 : SP_2017_RD0524_107_214_20170316_00249.jpg

LM Start	5.58	Rating **	U	Issue No.	214 (cont)
LM End	5.58	Issue Type +	Ma	Location *	LS

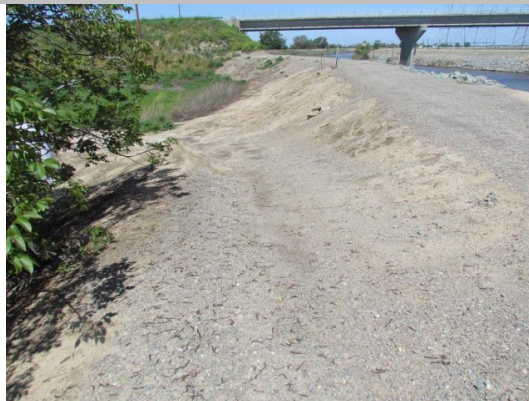
Photo 2 of 3 : SP_2017_RD0524_107_215_20170316_00251.jpg

LM Start	5.64	Rating **	U	Issue No.	215 (cont)	
LM End	5.64	Issue Type +	Ma	Location *	LS	
Category	Earthen Levee			GPS Latitude/Longitude		
				Start		End
Item	Slope Stability			37.877378 °		37.877378 °
				-121.332343 °		-121.332343 °
DWR ID	DWR_RD0524_01_s_2016_215					
Comment Code						
S1 : Repair slope instability.						
Inspector Comment						
Levee slope damage is due vehicle traffic and foot traffic. Vehicle traffic created a ramp on landward slope.

Looking north at slope damage (ramp) on landward slope.

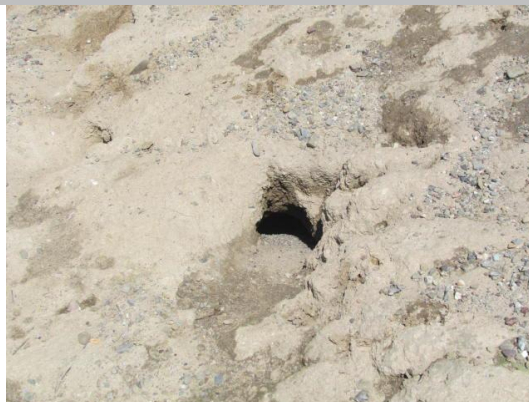
Photo 1 of 2 : SP_2017_RD0524_107_69_20170316_00113.jpg

LM Start	5.64	Rating **	U	Issue No.	69
LM End	5.80	Issue Type +	Ma	Location *	LS
Category	Earthen Levee			GPS Latitude/Longitude	
				Start	End
Item	Animal Control			37.877298 °	37.875073 °
				-121.332343 °	-121.333168 °
DWR ID	DWR_RD0524_01_s_2012_69				
Comment Code					
A3 : No rodents visible, but rodent burrows visible; need to backfill and compact or grout burrows.					
Inspector Comment					
District has grouted rodent holes. But rodents have re-appeared.

Looking south at rodent holes on landward slope.
